# FULL RESERVE STUDY

## Winterport Cluster

**Reston, Virginia**

**June 16, 2016**

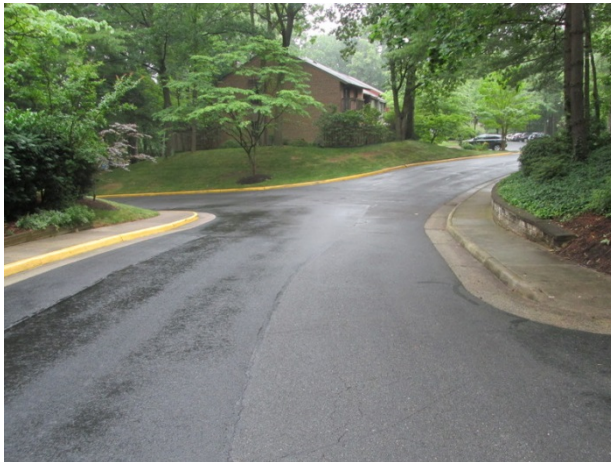
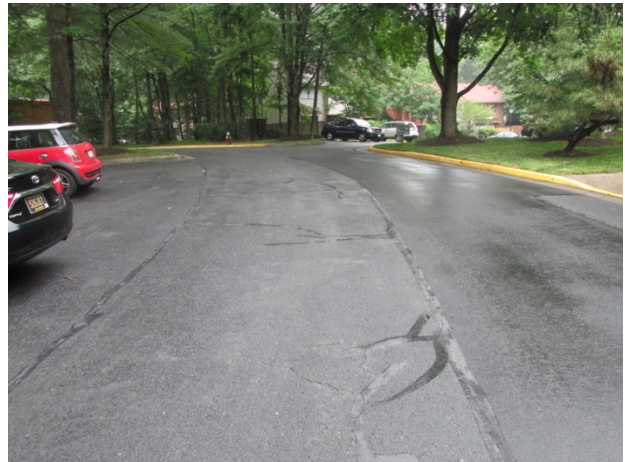
**Asphalt Pavement, Crack Repair, Patch and Seal Coat** - Asphalt pavement comprises 6,850 square yards of parking areas throughout the community. The pavement is in good to fair overall condition at an age of 12 years. We note cracks and deterioration. The Board informs us the Association applied a seal coat and conducted pavement repairs in 2014. The Association should plan future applications and repairs every three- to five-years. These activities reduce water infiltration and the effects of inclement weather. We elaborate on solutions and procedures necessary for the optimal maintenance of asphalt pavement in the following discussion.

**Asphalt pavement overview**

**Pavement overview**

We recommend periodic seal coat applications, crack repairs and patching to maintain the pavement. These activities minimize the damaging effects of vehicle fluids, maintain a uniform and positive appearance, and maximize the useful life of the pavement. Asphalt pavement is susceptible to isolated areas of accelerated deterioration in areas that experience freeze-thaw cycles, at the centerlines of streets and at high traffic areas such as intersections. Depressions often appear at areas where vehicles park such as driveways and parking areas. Isolated areas of

We recommend Winterport Cluster plan the next application of seal coat by 2018 and subsequent applications every four years thereafter except when repaving occurs. Line Item 4.020 of *Reserve Expenditures* notes our estimate of future costs and anticipated times of these activities.

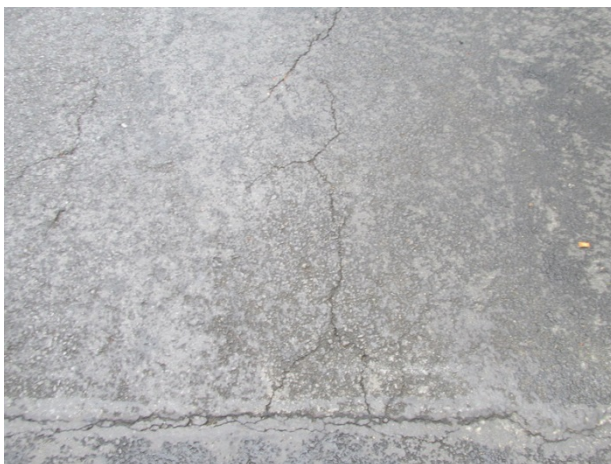
**Pavement cracks**

depressions, cracks and deterioration indicate the need for crack repairs and patching. The contractor should patch areas that exhibit potholes, alligator or spider web pattern cracks, and areas of pavement that are severely deteriorated from oil and gasoline deposits from parking vehicles. Area patching requires total replacement of isolated areas of pavement. The contractor should mechanically rout and fill all cracks with hot emulsion. Crack repair minimizes the chance of the cracks transmitting through the pavement.

Winterport Cluster should repair any isolated areas of deteriorated pavement prior to seal coat applications. Proposals for seal coat applications should include crack repairs and patching. The contractor should only apply seal coat applications after repairs are completed. A seal coat does not bridge or close cracks, therefore, unrepaired cracks render the seal coat applications useless. Our future estimates of cost include an allowance for repair activities.

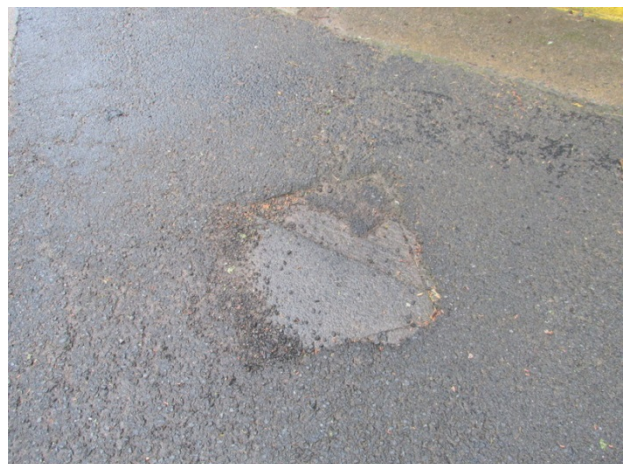
**Asphalt Pavement, Repaving** – As stated in the previous narrative, asphalt pavement comprises 6,850 square yards of parking areas throughout the community. The pavement is in good to fair overall condition at an age of 12 years. We note cracks and deterioration.

**Pavement deterioration**

The manner of repaving is either a mill and overlay or total replacement. A mill and overlay is a method of repaving where cracked, worn and failed pavement is mechanically removed or milled until sound pavement is found. A new layer of asphalt is overlaid atop the remaining base course of pavement. Total replacement includes the removal of all existing asphalt down to the base course of aggregate and native soil followed by the application of two or more new lifts of asphalt. We recommend mill and overlayment on asphalt pavement that exhibits normal deterioration and wear. We recommend total replacement of asphalt pavement that exhibits severe deterioration, inadequate drainage, pavement that has been overlaid multiple times in the past or where the configuration makes overlayment not possible. Based on the apparent visual condition and configuration of the asphalt pavement, we recommend the mill and overlay method for initial repaving followed by the total replacement method for subsequent repaving at Winterport Cluster.

A variety of repairs are necessary to deteriorated pavement prior to the application of an overlay. The contractor should use a combination of area patching, crack repair and milling before the overlayment. Properly milled pavement removes part of the existing pavement and permits the overlay to match the elevation of adjacent areas not subject to repaving. Milling also allows the contractor to make adjustments to the slope of the pavement to ensure proper drainage. The contractor should clean the milled pavement to ensure proper bonding of the new overlayment. We recommend an overlayment thickness that averages 1½ inches (not less than one inch or more than two inches). Variable thicknesses are often necessary to create an adequate slope for proper drainage. The contractor should identify and quantify areas of pavement that require area patching, crack repair and milling to help the Association compare proposed services.

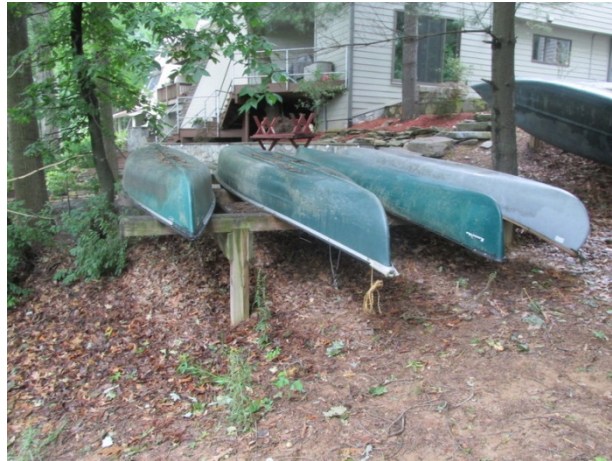
**Canoe Racks** - Winterport Cluster maintains four canoe racks near shoreline and dock. The canoe racks are in good condition at an age of seven years.

**Typical canoe rack**

These elements have a useful life of 10- to 15-years. We recommend the Association budget for replacement by 2029 and again by 2044. We depict this information on Line Item 4.080 of *Reserve Expenditures*. Our estimate of cost is based on historical cost for complete replacement of the canoe racks.

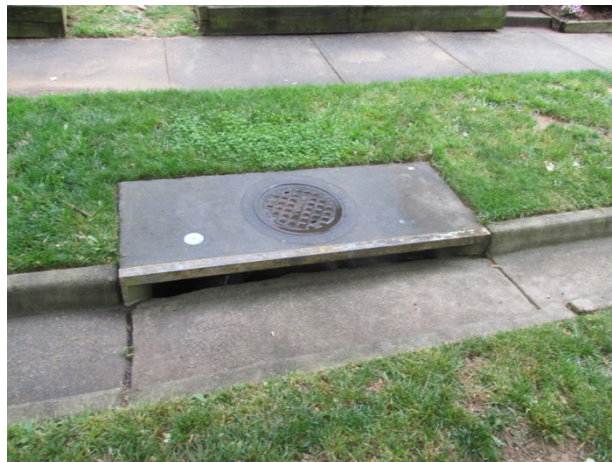
**Catch Basins** - The five concrete catch basins collect storm water from the pavement and conduct it into the storm water system. The overall condition of the catch basins is good without settlement visually apparent.

**Catch basin**

The useful life of catch basins is indeterminate with proper maintenance which includes interim capital repairs or partial replacements every 15- to 20-years. The Association should anticipate the occasional displacement or failure of a catch basin and the surrounding pavement from erosion. Erosion causes settlement around the collar of catch basins. Left unrepaired, the entire catch basin will shift and need replacement. Winterport Cluster should plan to repair or replace any displaced or failed catch basins concurrently with the surrounding pavement, and curbs and gutters. The exact times and amount of capital repairs or replacements are dependent upon variable natural forces. Based on the age and condition of the catch basins, we recommend the Association anticipate the inspection, capital repair or partial replacement of the five catch basins in conjunction with each repaving event. We include this information on Line Item 4.100 of *Reserve Expenditures*.

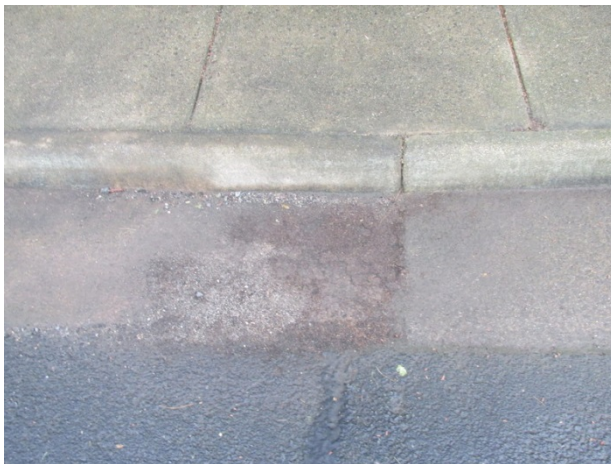
**Concrete Curbs and Gutters** - The Association maintains 4,000 linear feet of concrete curbs and gutters throughout the community. The curbs and gutters are in fair overall condition. We note settlement and damage.

**Concrete curb and gutter settlement**

These applications of concrete have useful lives of up to 65 years although isolated deterioration of limited areas of concrete is common. Inclement weather, inadequate subsurface preparation and improper concrete mixtures or finishing techniques can result in premature deterioration such as settlement, chips, cracks and spalls. Variable conditions like these result in the need to plan for periodic partial replacements of the concrete curbs and gutters throughout the next 30 years.

We estimate that up to 1,200 linear feet of concrete sidewalks, or thirty percent (30%) of the total, will require replacement during the next 30 years. We recommend the Association budget for replacement of up to 600 linear feet in conjunction with each repaving event. Line Item 4.110 of *Reserve Expenditures* notes our estimate of future costs and anticipated times of replacements. We base our estimate of replacement on 3,000 psi (pounds per square inch) concrete with 6x6 - W1.4xW1.4 steel reinforcing mesh. The times and costs of these replacements may vary. However, the estimated expenditures detailed in *Reserve Expenditures* are sufficient to budget appropriate reserves.

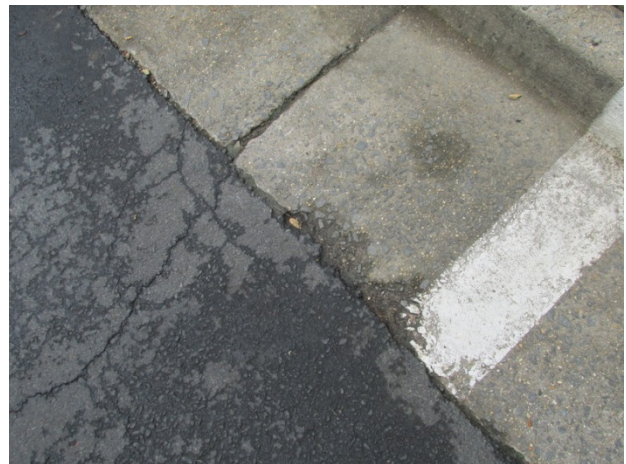
**Curb and gutter damage**

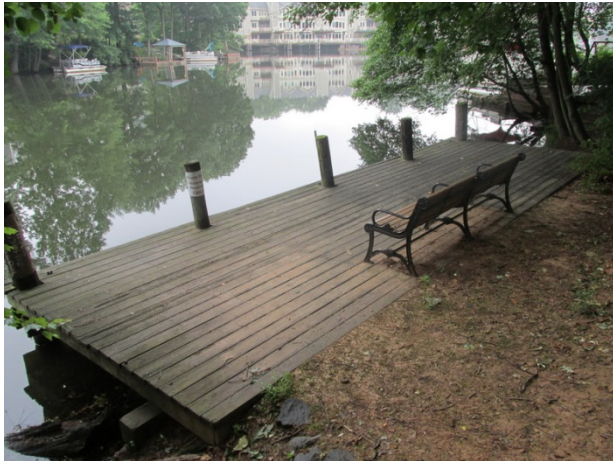
**Dock** - Winterport Cluster maintains a wood dock at the shoreline comprising approximately 320 square feet. The wood dock sits atop wood pilings. The wood dock and pilings are in fair condition at an age of 22 years. The pilings and structure have a useful life of 45- to 50-years and the deck boards have a useful life of 15- to 20-years. We note a split board.

**Dock overview**

We recommend the Association anticipate partial replacement of the wood dock by 2017. Partial replacement should include replacement of the deck boards and partial repairs and/or replacement of the wood structure and pilings. Winterport cluster should plan for complete replacement of the dock and pilings by 2027. We depict this information on line items 4.200 and 4.220 of *Reserve Expenditures*.

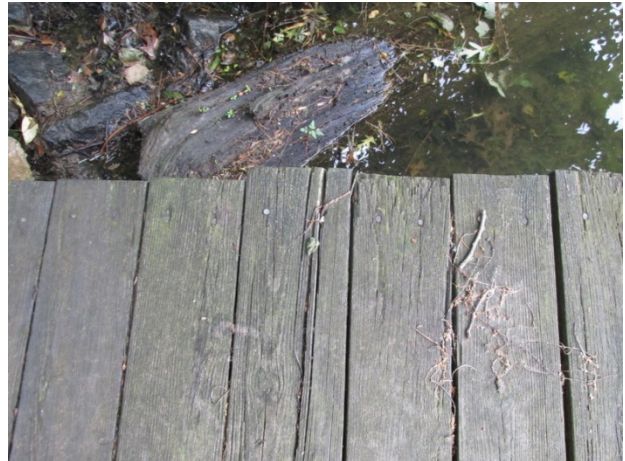
**Split board at dock**

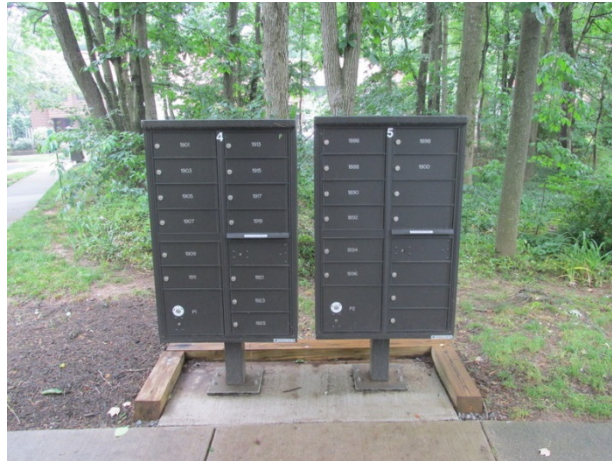
**Mailbox Stations** - The Association maintains seven metal mailbox stations throughout the property that serve the residents of Winterport Cluster. The mailbox stations are in good condition at an age of one year and have a useful life of up to 25 years.

#### **Mailbox stations**

Winterport Cluster should budget for replacement of the mailbox stations by 2040. We depict this information on Line Item 4.600 of *Reserve Expenditures*. The Association should verify the new mailboxes meet the specifications of the *United States Postal Service*.

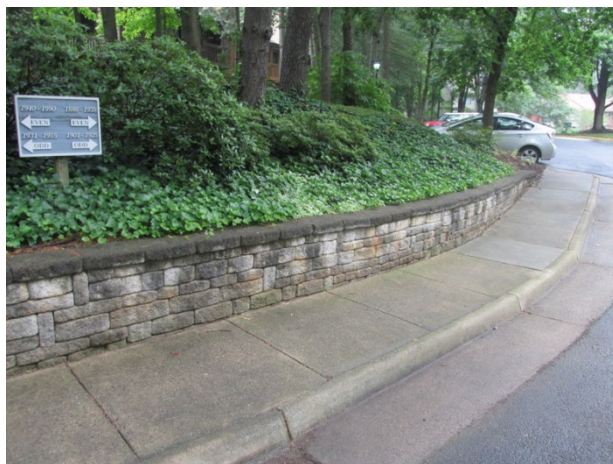
**Retaining Walls, Masonry** - The Association maintains four retaining walls which comprises approximately 180 square feet of interlocking dry-set masonry at the entrance sign and at the south parking area. The retaining walls are in good to fair overall condition at an age of 10 years. We note lean.

**Masonry retaining wall overview**

Interlocking masonry retaining walls have useful lives of up to 35 years. We recommend the Association plan for replacement by 2038. We depict this information on Line Item 4.745 of *Reserve Expenditures*. The Association should fund for repairs or partial replacements through the operating budget.

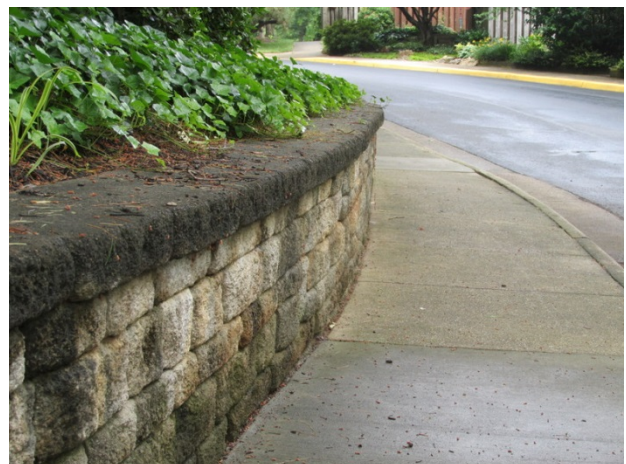
**Retaining wall lean**

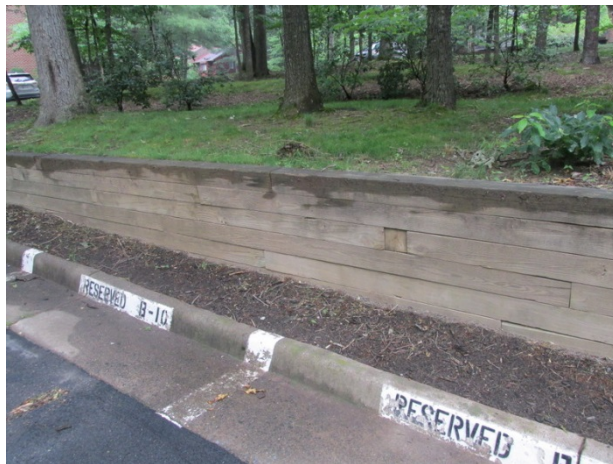
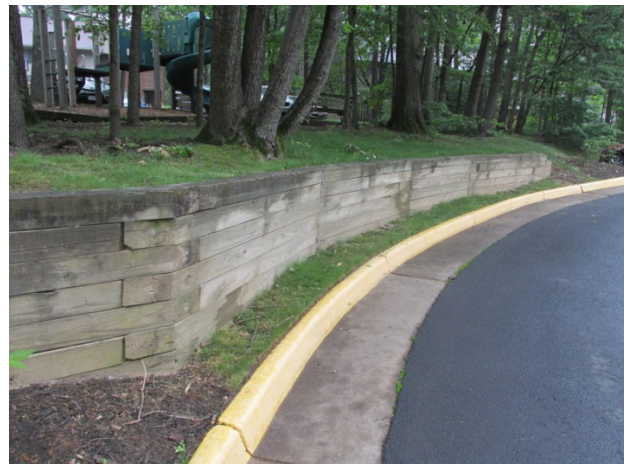
**Retaining Walls, Timber** - The Association maintains approximately 400 square feet of wood timber retaining walls throughout the Association. The retaining walls are in fair overall condition at various ages of up to 11 years.

**Timber retaining wall overview**

**Retaining wall overview**

Timber retaining walls have a useful life of 15- to 20-years. We recommend the Association anticipate replacement by 2023 and again by 2043. We advise Winterport Cluster replace with a modular, interlocking dry-set masonry retaining wall system. We include the following cost analysis table to illustrate the cost benefits of replacement with interlocking masonry:

As shown in the cost analysis table above, the cost of dry-set masonry retaining walls is similar to the cost of timber walls. However, dry-set masonry retaining walls offer a longer useful life of up to 35 years making this type of retaining wall the less expensive option by about \$380 dollars in annual cost of ownership. We include this information on Line Item 4.760 of *Reserve Expenditures*.

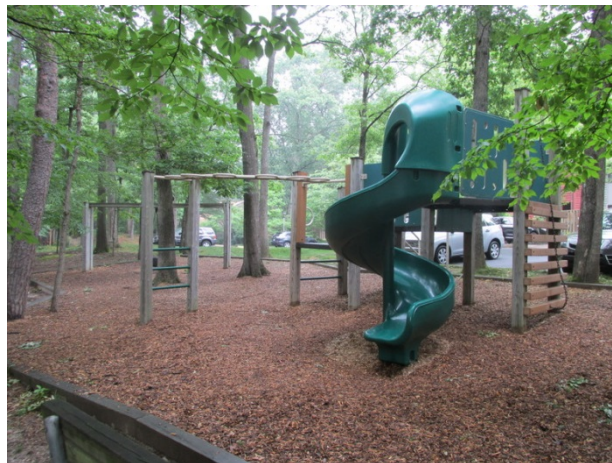
**Tot Lot** - The Association maintains a tot lot near the center of the community. The playground equipment includes a tire swing and a playset. The playground equipment is in fair condition at an age of 15 years.

**Tot lot playset**

Safety is the major purpose for maintaining playground equipment. We recommend an annual inspection of the playground equipment to identify and repair as normal maintenance

loose connections and fasteners or damaged elements. We suggest the Association learn more about the specific requirements of playground equipment at [PlaygroundSafety.org](http://PlaygroundSafety.org). We recommend the use of a specialist for the design or replacement of the playground equipment environment. Playground equipment of this type has a useful life of 15- to 20-years. We recommend replacement of the playground equipment at the tot lot by 2019 and again by 2039. We include this information on Line Item 4.830 of *Reserve Expenditures*.
